**[Docket No. FAA-2012-0887; Directorate Identifier 2009-SW-02-AD]**

**Airworthiness Directives; Eurocopter Deutschland GmbH Helicopters**

**ACTION:** Notice of proposed rulemaking (NPRM).

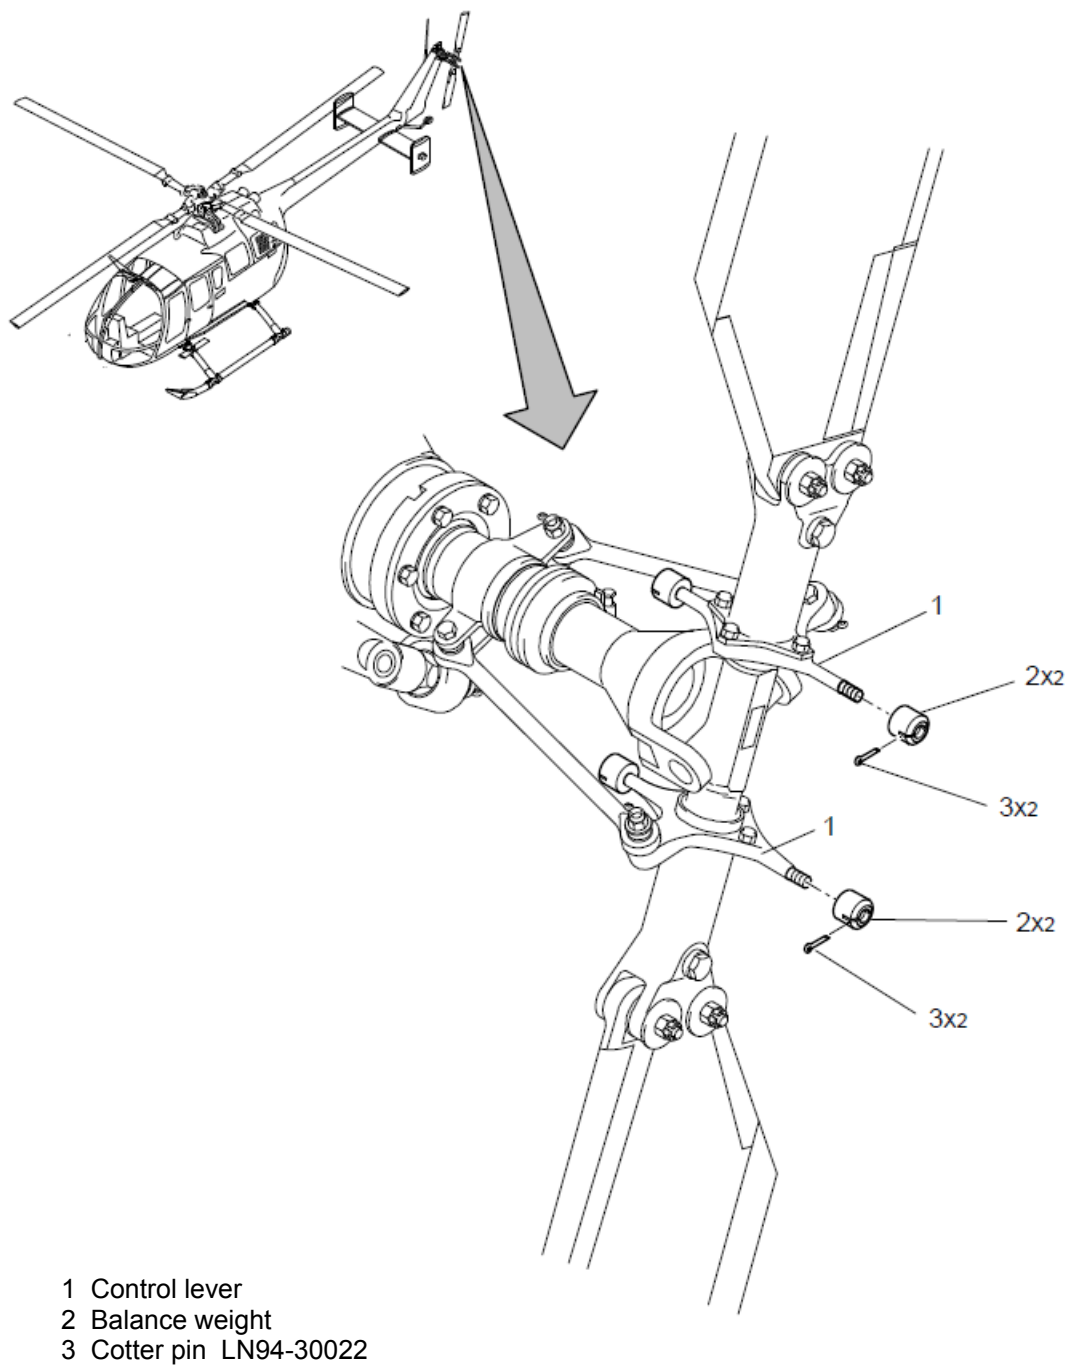
Figure 1 to paragraph (d) Tail Rotor Balance Weights

This AD defines the unsafe condition as corrosion or thread damage in the threaded area of a lever or weight. This condition could result in failure of a weight or lever, separation of a tail rotor part, severe tail rotor vibration, and subsequent loss of control of the helicopter.

(1) Remove the weights from the lever as depicted in Figure 1 to paragraph (d) of this AD. Apply marks to the weights before they are removed in order to be able to re-establish the correct assignment and the old installation position towards the lever when the weights are installed.

(3) Apply corrosion preventive paste onto the thread of the lever and install weights to the lever as depicted in Figure 1 to paragraph (d) of this AD. Ensure during

installation of the weights that the weights are correctly assigned and installed to the control lever in accordance with the applied marks.

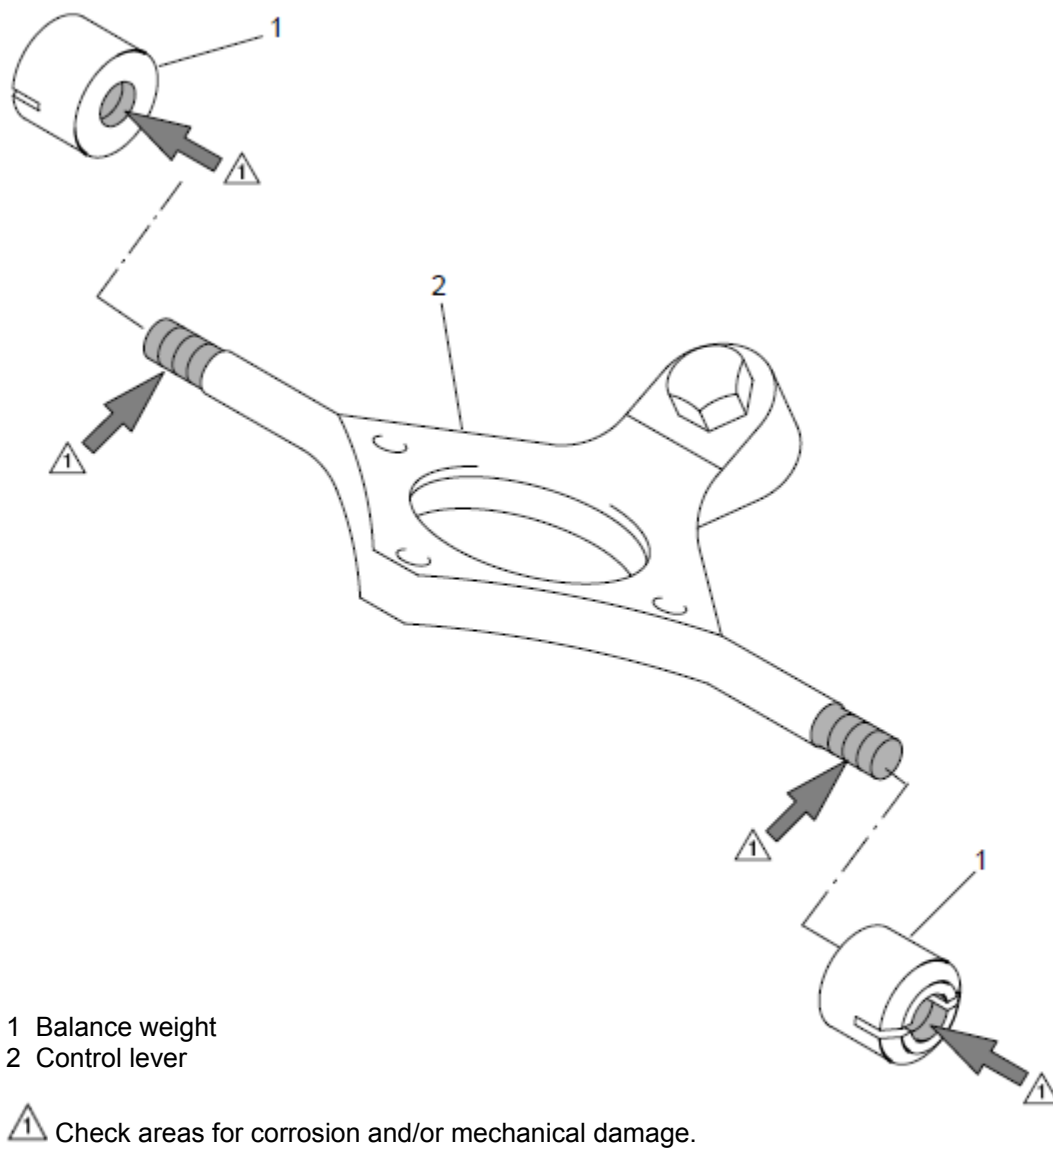
Figure 2 to paragraph (d) Inspection of Balance Weights and Control Lever

(2) Visually inspect each weight and lever for corrosion and damage in the threaded areas as depicted in Figure 2 to paragraph (d) of this AD.

(A) If the total area of corrosion or thread damage, or both, covers less than 25 percent of the length of the threaded area, the weight can be threaded (screwed) onto the lever, and the cylindrical mating surface has no damage, before further flight, remove the corrosion and reinstall the weight by following paragraph (d)(3) of this AD.

(B) If the total area of corrosion or thread damage, or both, covers 25 percent or more of the length of the threaded area, the weight cannot be threaded (screwed) onto the lever, or the cylindrical mating surface has damage, before further flight, replace the weight with an airworthy weight by following paragraph (d)(3) of this AD.

(iii) If there is corrosion or thread damage on the threaded portion of the lever, polish out the corrosion and thread damage using a polishing cloth 600 and:

(A) If the thread depth does not exceed 0.3 millimeter (mm) and the diameter of the lever in the area before the threaded area is not less than 9.95 mm after polish out, before further flight, install airworthy weights to the lever by following paragraph (d)(3) of this AD.

(B) If the thread depth is 0.3 mm or greater or the diameter of the lever in the area before the threaded area is less than 9.95 mm after polish out, before further flight, replace the lever with an airworthy lever.
